Land Management Annual Monitoring Report

1215 Centre St. West Roxbury, MA
DEP FILE: 006-1926

November 2023

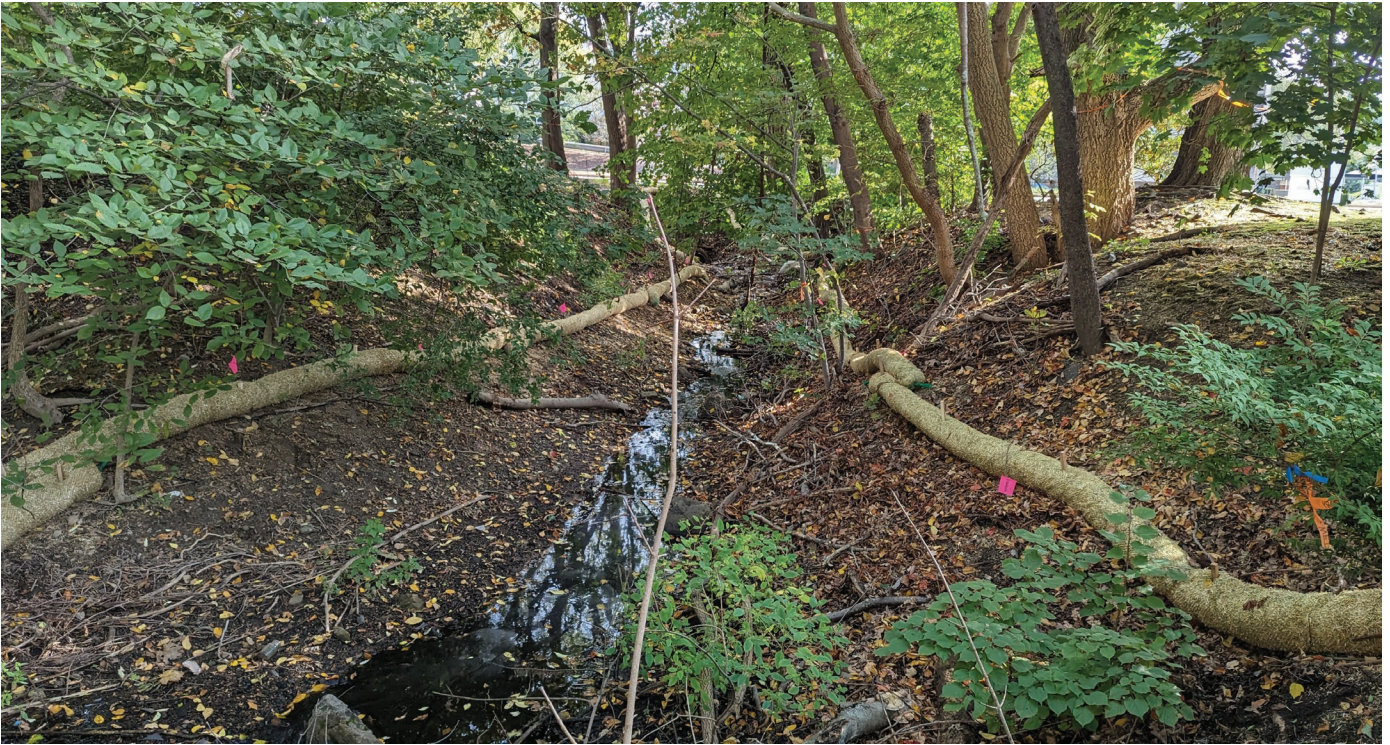
Erosion control waddle (12") installed just above the wetland line marks the limit of invasive species management and slows any erosion from entering the wetland

- On October 6th, Parterre Ecological oversaw installation of erosion control along the limit of work and just above the wetland marking line, per specification. The majority of the control consisted of 12" straw waddle and in areas where the slope was particularly steep or eroded along the bank, straw bails were added as extra support.
- Additionally, Japanese Knotweed on site was treated along the fence line using a foam-based Glyphosate herbicide (Rodeo) wiped on the leaves to prevent any over-spray. Followup treatment will be required in 2024.

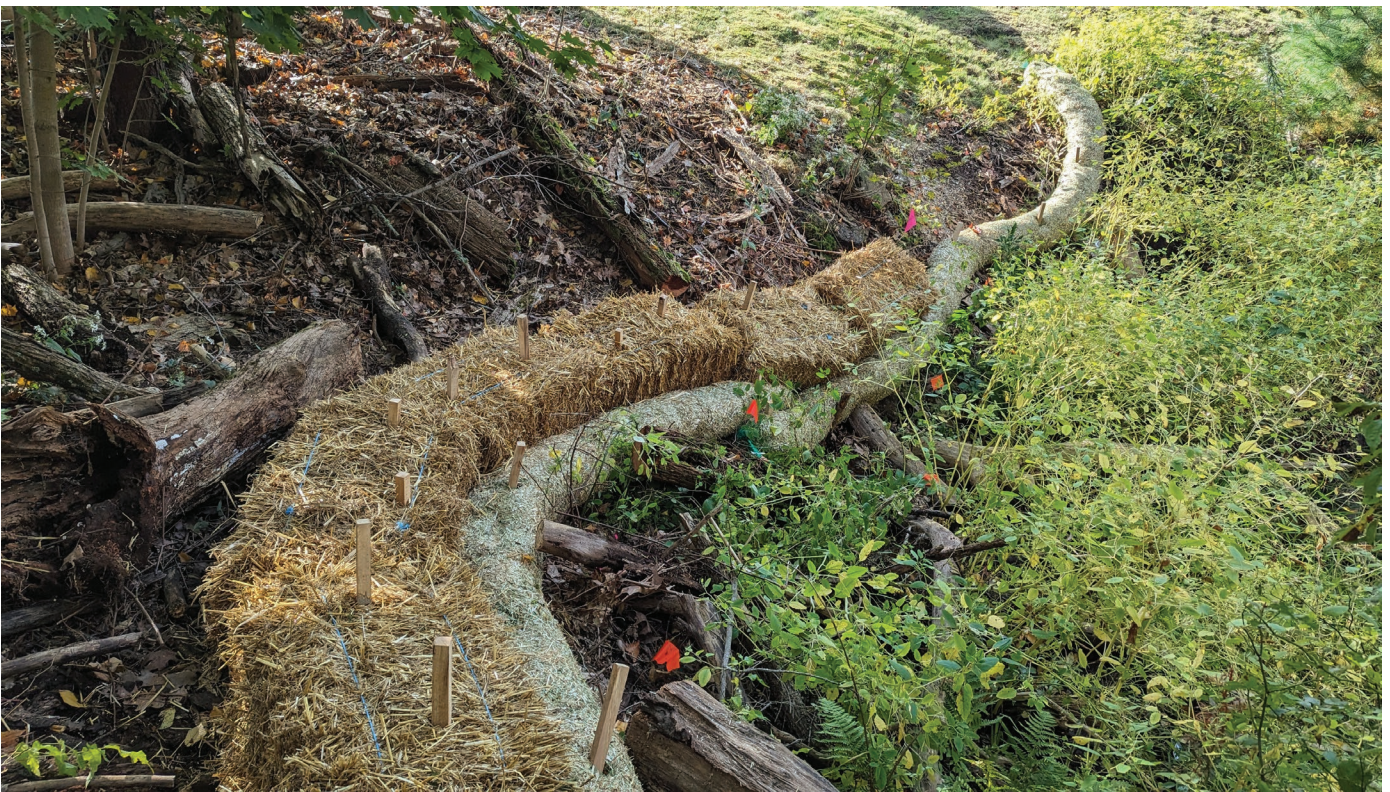
Straw bales placed along the top the straw waddle to further protect from sediment entering the wetland in certain areas

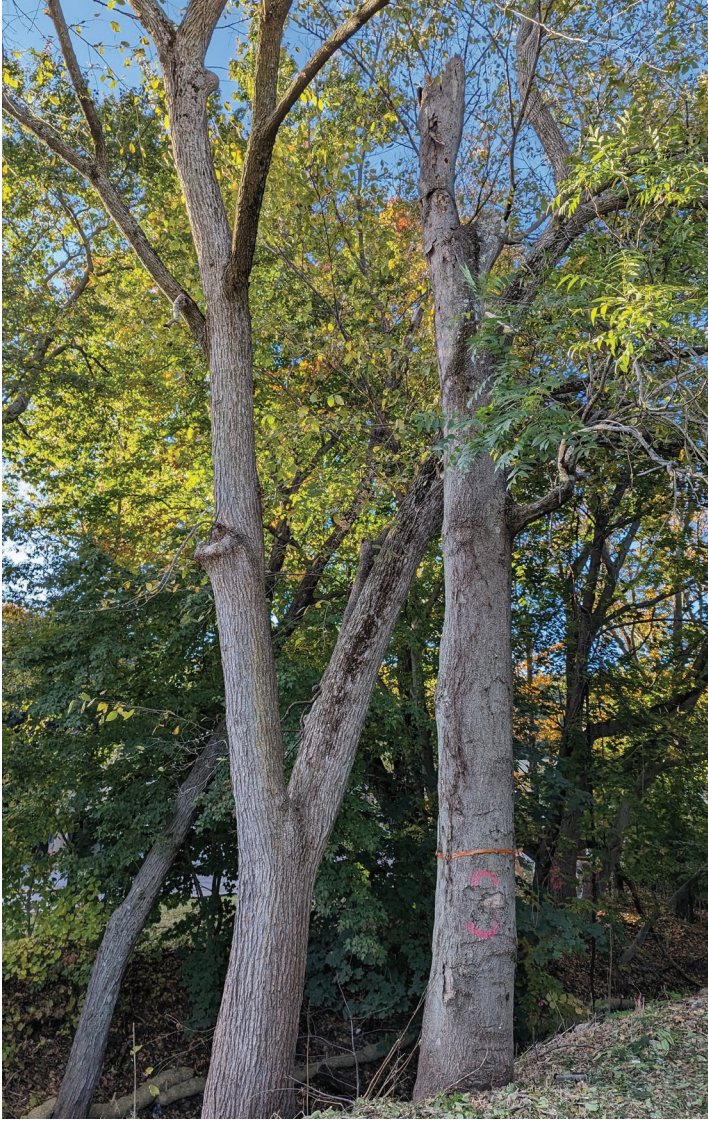
Ailanthus altissima cut at 30° as a snag

After the sediment control was in place Parterre Ecological oversaw removal of invasive trees on Oct. 19-20 per the LMP plan. Two large trees (One *Ailanthus altissima*, One *Phellodendron amurense*) were cut at 25-30' heights and treated at the base to provide snag habitat. Most of the other trees were cut and removed with the *Robina pseudoacacia* left on site for future milling into planks. Tree Tech cut stumps at 4" height so they could be re-cut and treated by Parterre staff. Two additional trees will be proposed for removal in the phase 2 portion of the plan. Care was taken to prevent any disturbance to the wetland area by the use of cranes.

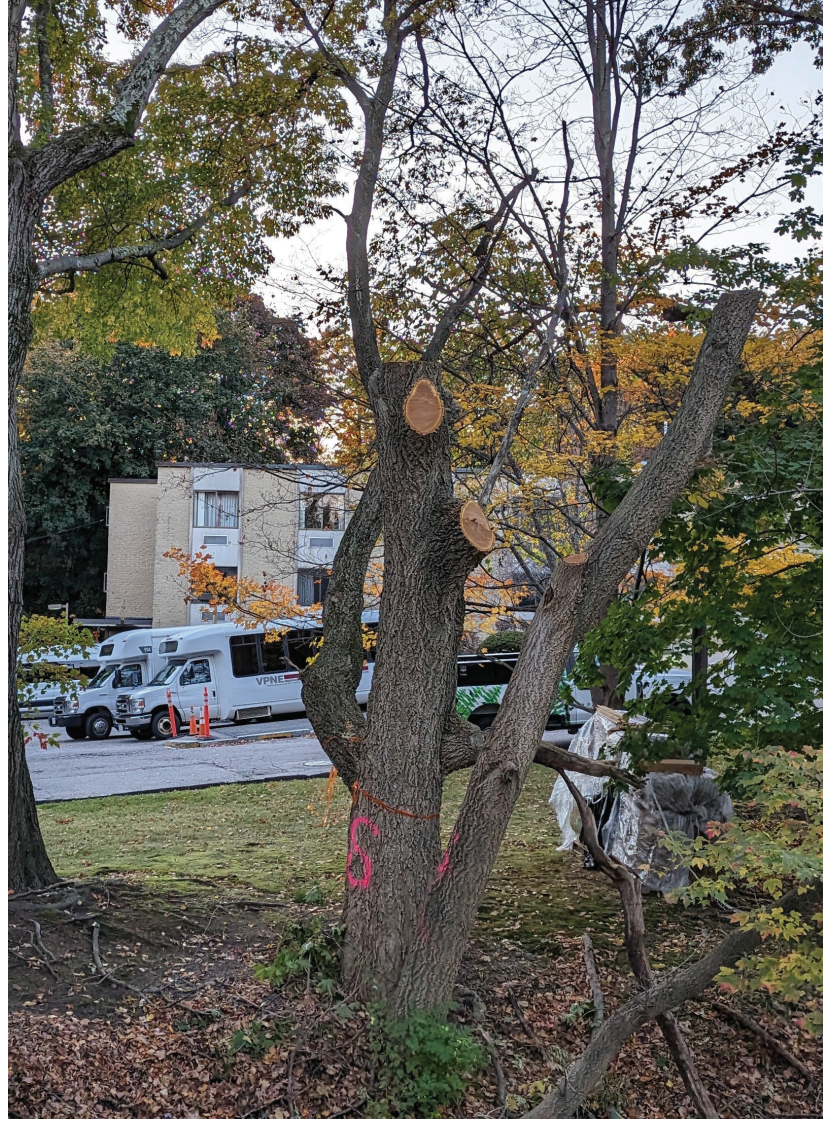
Phellodendron amurense cut at 30' as a snag in three places

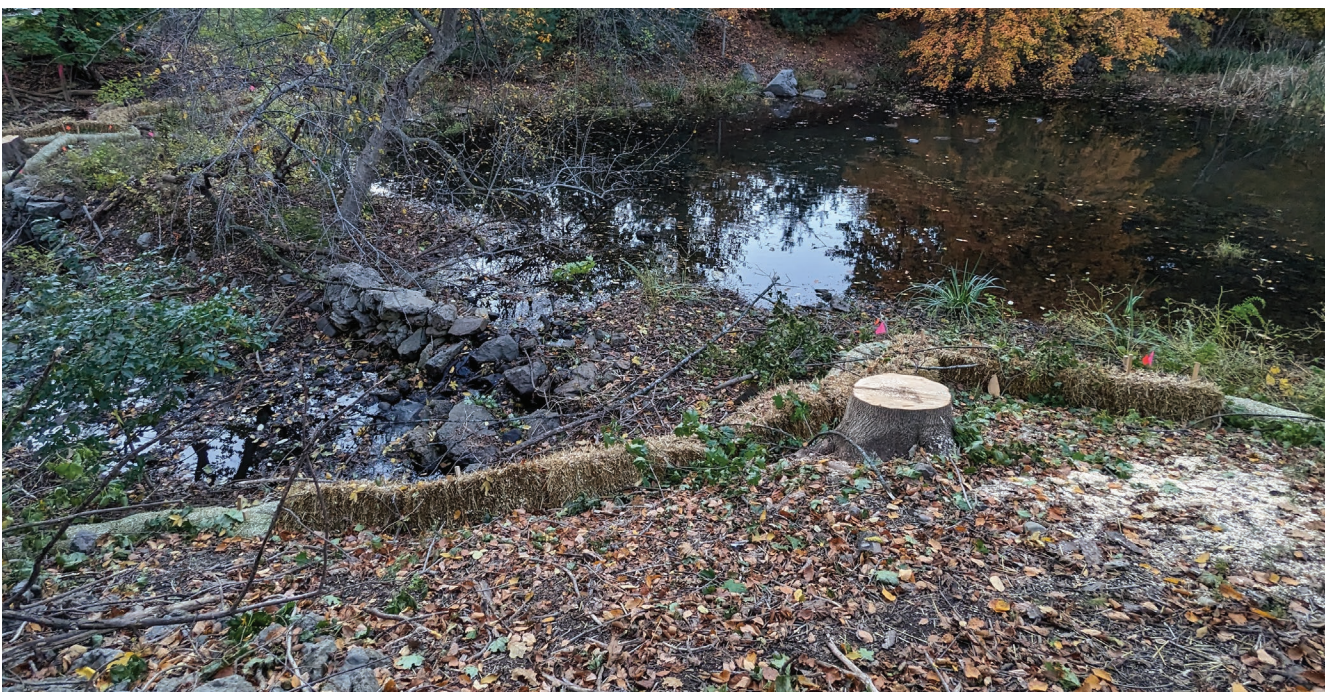
The Norway Maple at the top of the dam after removal. It was re-cut and dabbed by Parterre team

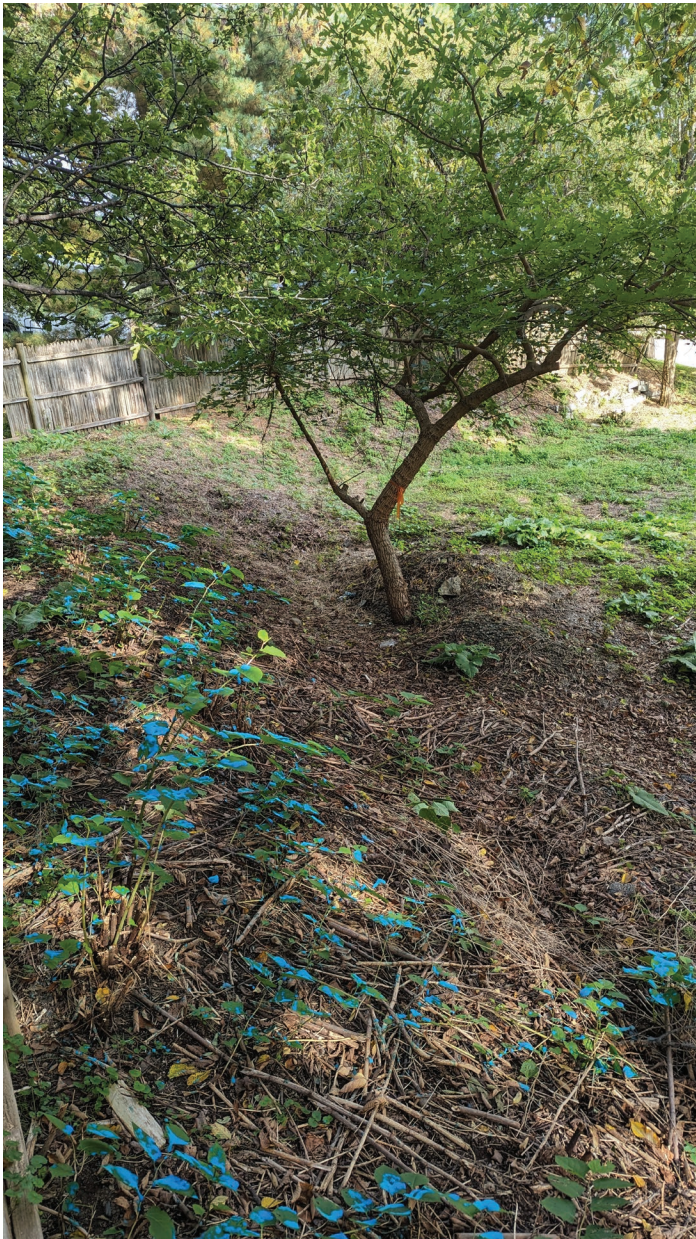
Japanese Knotweed (Fallopia japonica) with foam treatment along the slope below the fence

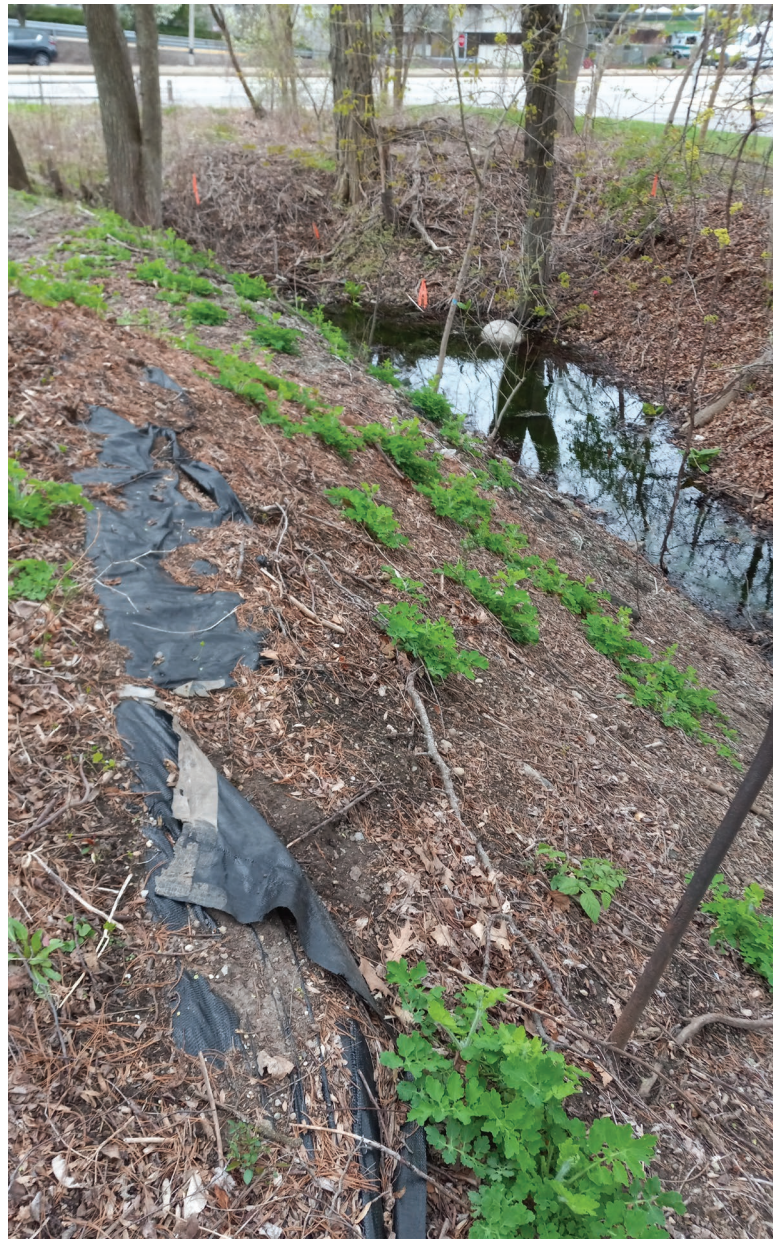
Invasive Greater Celandine (Chelidonium majus) before removal. All silt fence and a large amount of asphalt were also removed

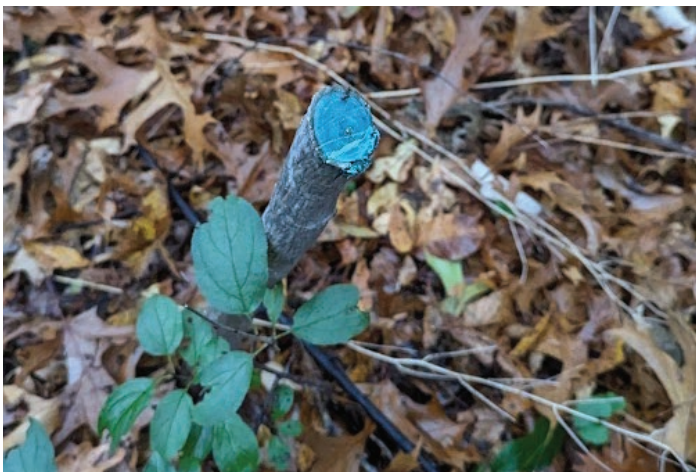
Buckthorn after dabbing with triclopyr-based herbicide

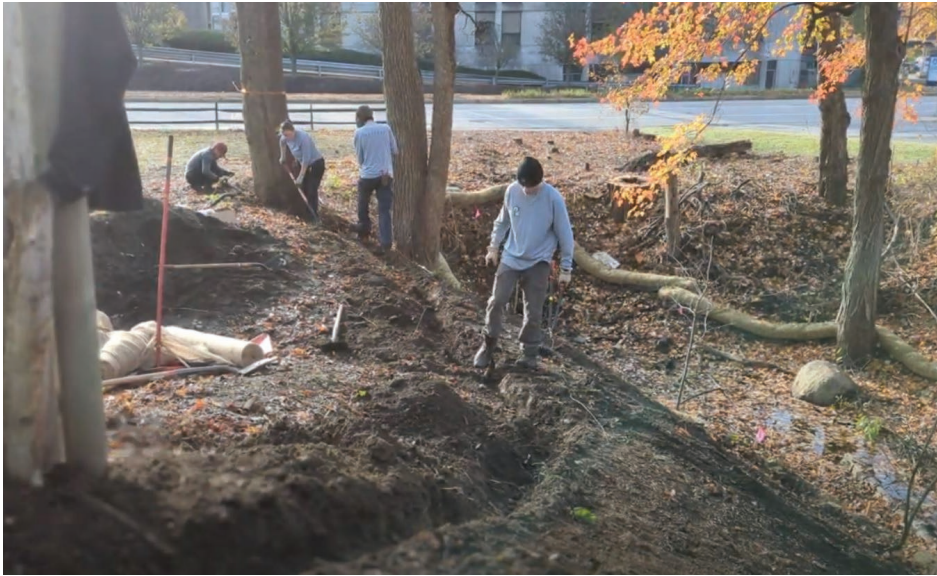
Restoration team digging trench to toe-in erosion control into the slope after grading. Care was taken to keep as much soil contact as possible to hold soil in place

- After removal the team prepared the slope by removing debris (including old silt fence, fence posts, pipe, and asphalt). The area was raked-out to ensure even grades on the slope. A trench was dug along the top of the slope to tie in erosion control of jute and burlap. After seeding with a conservation wild/wetland seed mix, erosion control blanket was laid over the slope and stapled in at 2' intervals. Each roll of erosion control blanket was overlapped by 1' per the Imp plan.

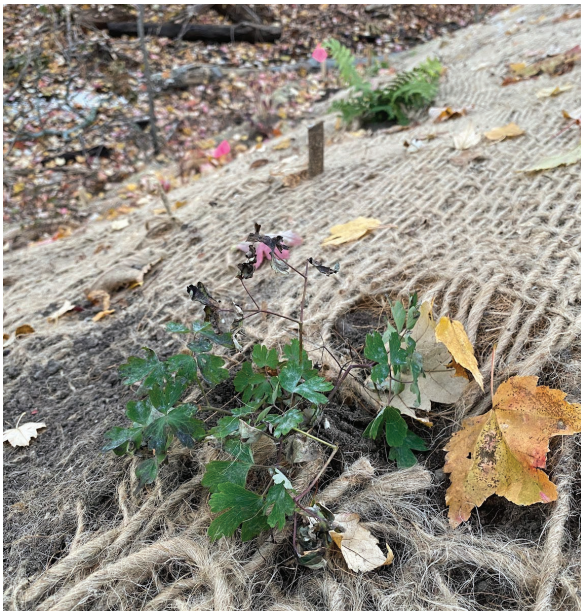
*Above left: *Aguilegea canadensis* dug into the slope stabilization fabric*

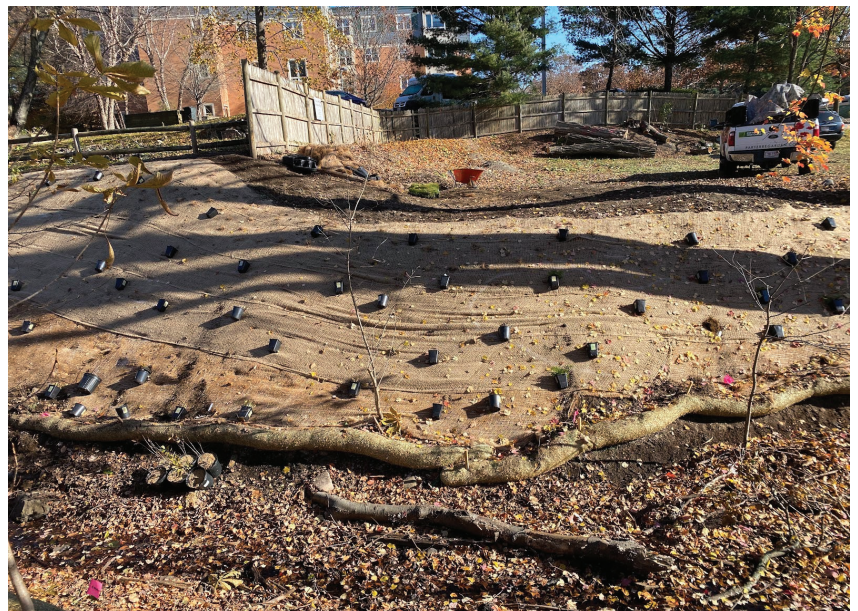
Above right: Layout of native plantings on slope

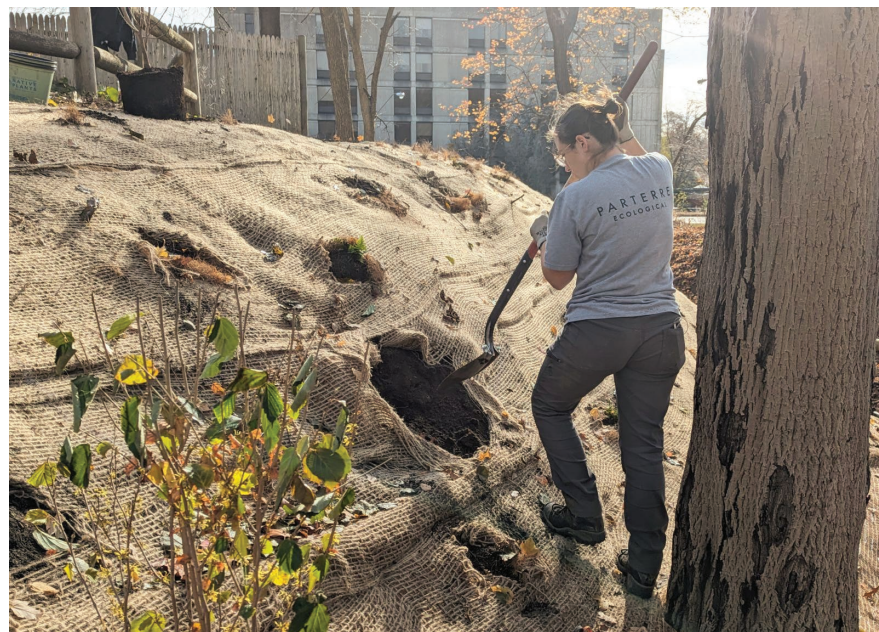
Left: Installation of shrubs and perennials within the erosion control

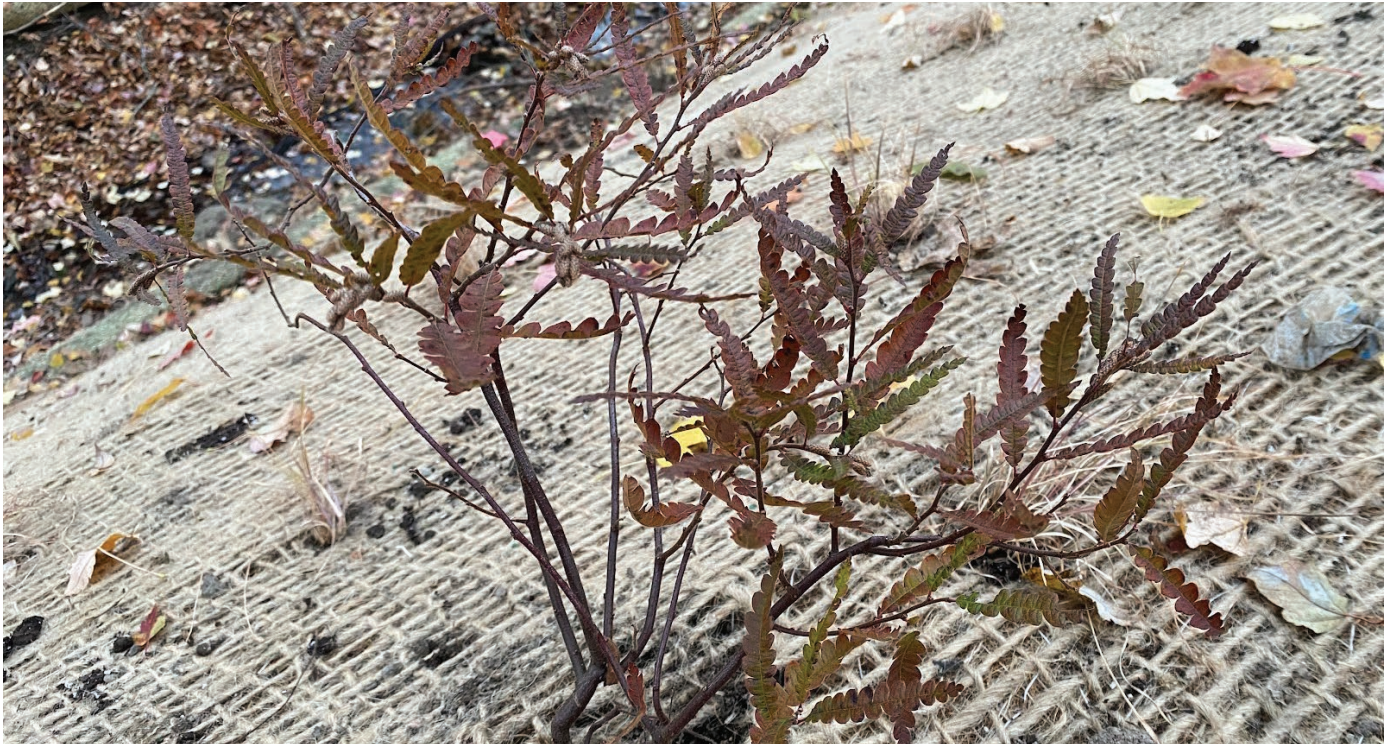
Comptonia peregrina planted at the top of the slope in the erosion control blanket

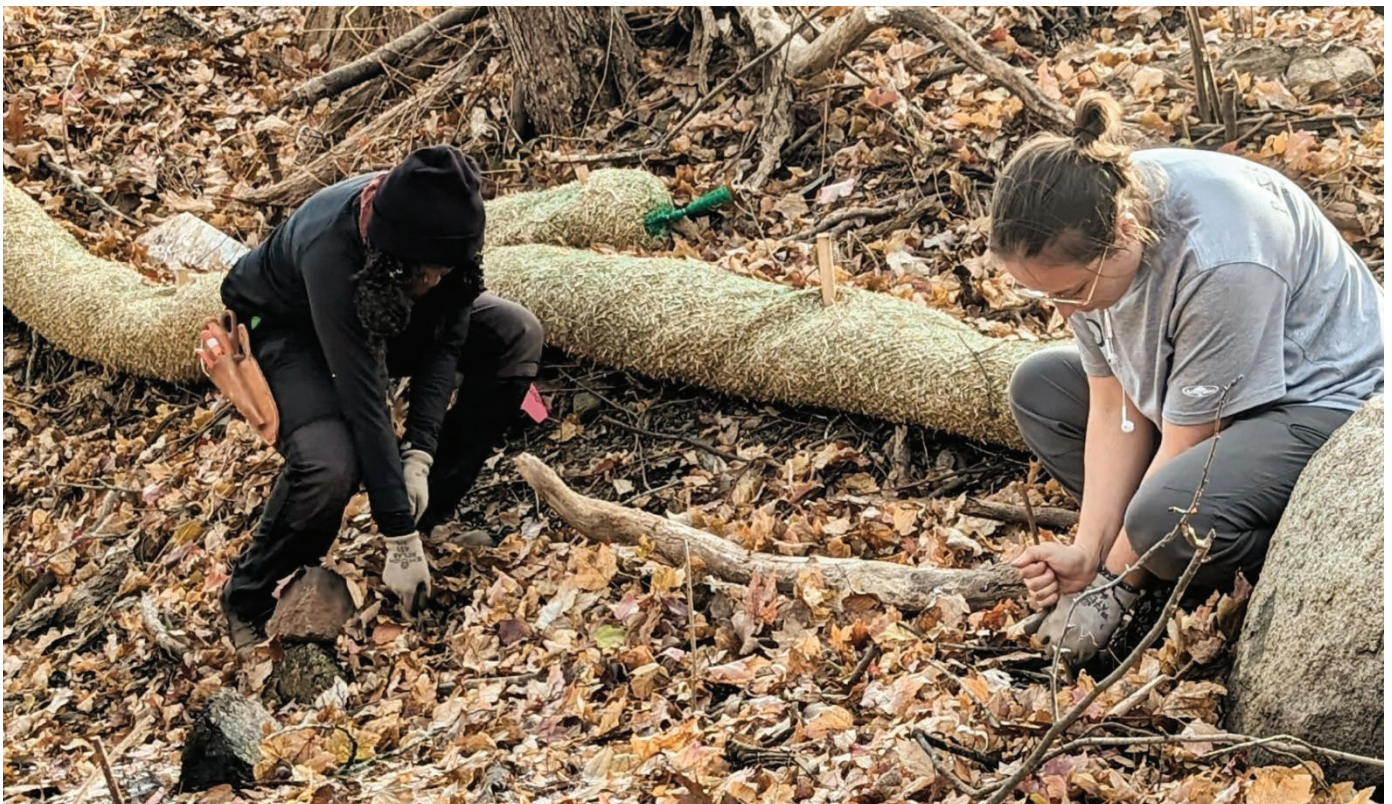
Live staking of native shrubs within the wetland area

- Live stakes of Elderberry, Dogwood, willow and Buttonbush were installed in the wetland edge.

Some of the live stakes were purchased and some were harvested from local wetlands. Each cutting was roughly 3' long and they were installed with a root hormone at the base of the stem.

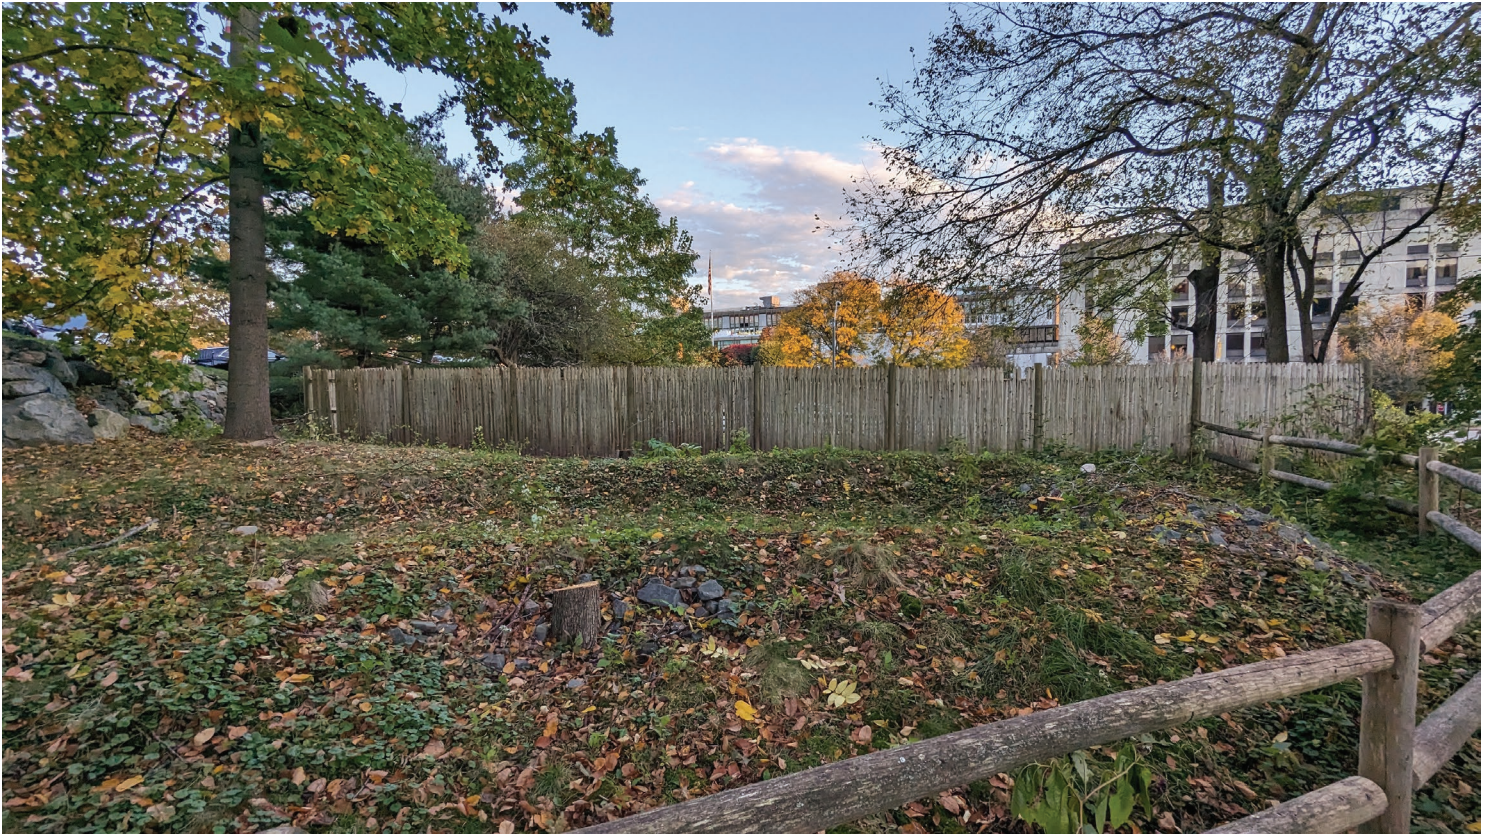
Area above the slope Bradford Pear were removed with a native Tulip tree left in place. The project is well-positioned to continue successful restoration into 2024.
